Cobra 138XLR / 139XLR Technical Bulletin 1209B

COBRA FIELD BULLETIN

SUBJECT: REVISION OF BULLETIN 1209 AND 1209A. D-26
SHORTING ON THE COBRA 138/139XLR.

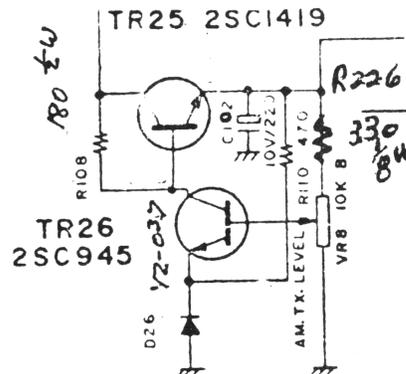
SYMPTOM: VERY WEAK POWER OUT OR NO A.M. TRANSMIT.
D-26 FOUND BAD.

1. CHANGE D-26 FROM A 5VOLT ZENER DIODE TO A 3.7V ZENER DIODE, DYNASCAN PART NO 152-084-9-001.
2. CHANGE R-108 FROM 270 OHM $\frac{1}{2}$ WATT TO 180 OHM, $\frac{1}{2}$ WATT, DYNASCAN PART NO 002-102-9-181.
3. ADD A 330 OHM $\frac{1}{8}$ WATT RESISTOR, DYNASCAN PART NO 002-108-5-331 FROM TOP OF VR8 A.M. TRANSMIT ADJUST TO EMITTER OF TR25. THE RESISTOR IS ADDED ON THE FOIL SIDE, CUTTING THE FOIL SO THE RESISTOR IS IN SERIES WITH VR8 AND THE EMITTER OF TR25. THE SCHEMATIC SYMBOL FOR THE RESISTOR IS R226.

4. ADJUST VR8 FOR 4 WATTS OUTPUT ON A.M. TRANSMIT
