Cobra 138XLR Technical Bulletin 1216

COBRA FIELD BULLETIN

SUBJECT: TR-36/R153 Crystal Drift Correction Modification Cobra 138XLR.

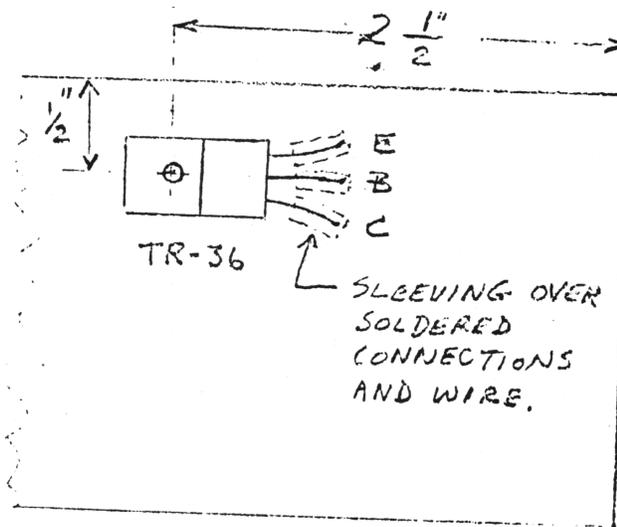
FIG. 1.

SYMPTOM: After the radio has been on a period of time, high temperatures are generated by TR36 & R153 causing excessive heating of the SSB crystals in the near proximity. This will appear as excessive transmitter or receiver drift on SSB operation.

1. Remove R153 56ohm 2W resistor. Replace resistor with a piece of the #22 AWG solid copper wire on P.C. board.
2. With the controls facing you, the component side up, remove TR36 ZSC1419B and relocate by mounting with a mica insulator, insulating shoulder washer, Phillips head screw, and hex nut, on the right side of main chassis (near mike connector).

1. Drill or punch a 1/8 inch diameter hole on the right side of the main chassis, near mike connector, 2½ inches from front edge of chassis and ½ inch from top. Be sure all drilling chips are removed from the radio. Any burrs in component side of hole must be removed by chamfering tool or other means.
2. Apply a small quantity of heat sink paste (Wakefield Thermal Compound) to both sides of the mica insulator and mount horizontally against the chassis. Then mount TR36 against the insulated shoulder washer, screw and nut. Make sure the shoulder on the insulating washer seats in the hole in the transistor heat sink.
3. Cut three pieces of #22 AWG stranded teflon or vinyl covered wire, colored orange, green and violet (or substitute colors

as required) into 6" lengths. Strip insulation 3/8" of each end and tin. Then mount each wire to the emitter-base collector of TR-36 and the opposite ends to the corresponding points on the P.C. board where the TR-36 transistor was previously mounted.
