**Cobra 139XLR Technical Bulletin 1218**

# DYNASCAN SERVICE OPERATIONS

## COBRA FIELD BULLETIN BULLETIN 1218

SUBJECT: COBRA 139XLR MODIFICATIONS

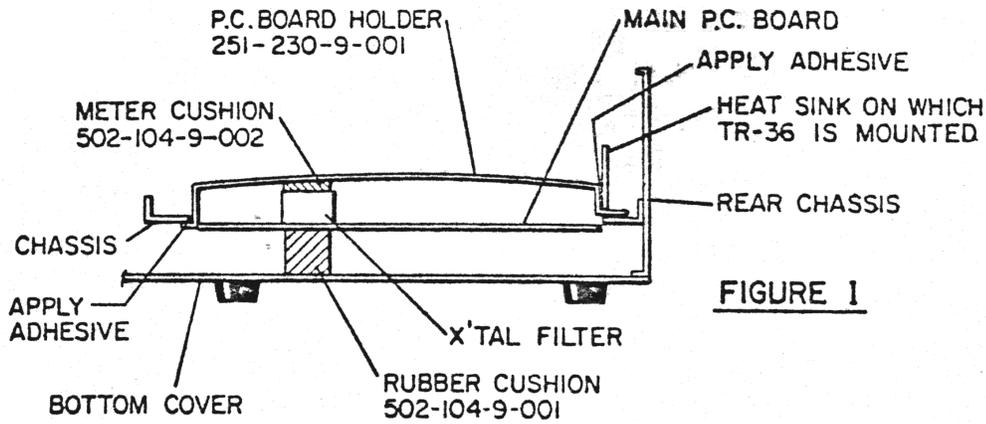
**FIGURE 1**

PROBLEM B. PCB cracking or breaking due to rough handling.

16. Paste two meter cushions (520-104-9-001) on top of Xtal filter (Fig. 1)

18. Install PC board holder (Longer flange under auxiliary heat sink, shorter flange under chassis)  
Fig 1.

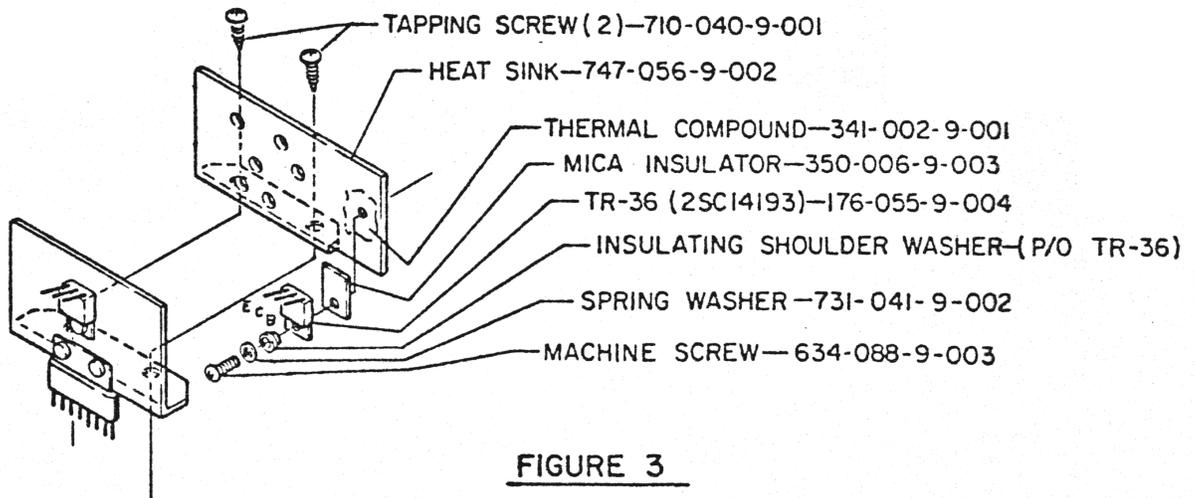
**FIGURE 3**

PROBLEM A. TR-36/R153 Crystal drift due to overheating.  
After radio has been on for a period of time, high temperature generated by TR-36 and R-153 overheats the SSB crystals thereby causing excessive transmitter or receiver drift on SSB operation.

7. Unsolder and remove TR-36 from present location.
8. Mount TR-36 on auxiliary heat sink (747-056-9-002 supplied with this mod. kit) using the existing hardware and insulators (Fit. 3). Apply thermal compound (341-002-9-001) on both sides of mica insulator before installation. When installing insulated shoulder washer, make sure that the smaller end seats in transistor hole. When tightening transistor mounting screw be careful not to damage insulated shoulder washer.
