Cobra 19 Plus Technical Bulletin 1297

1297

October 11, 1988

MODELS AFFECTED : 19 Plus A (19 Plus, S/N 80809883 to 80915252)

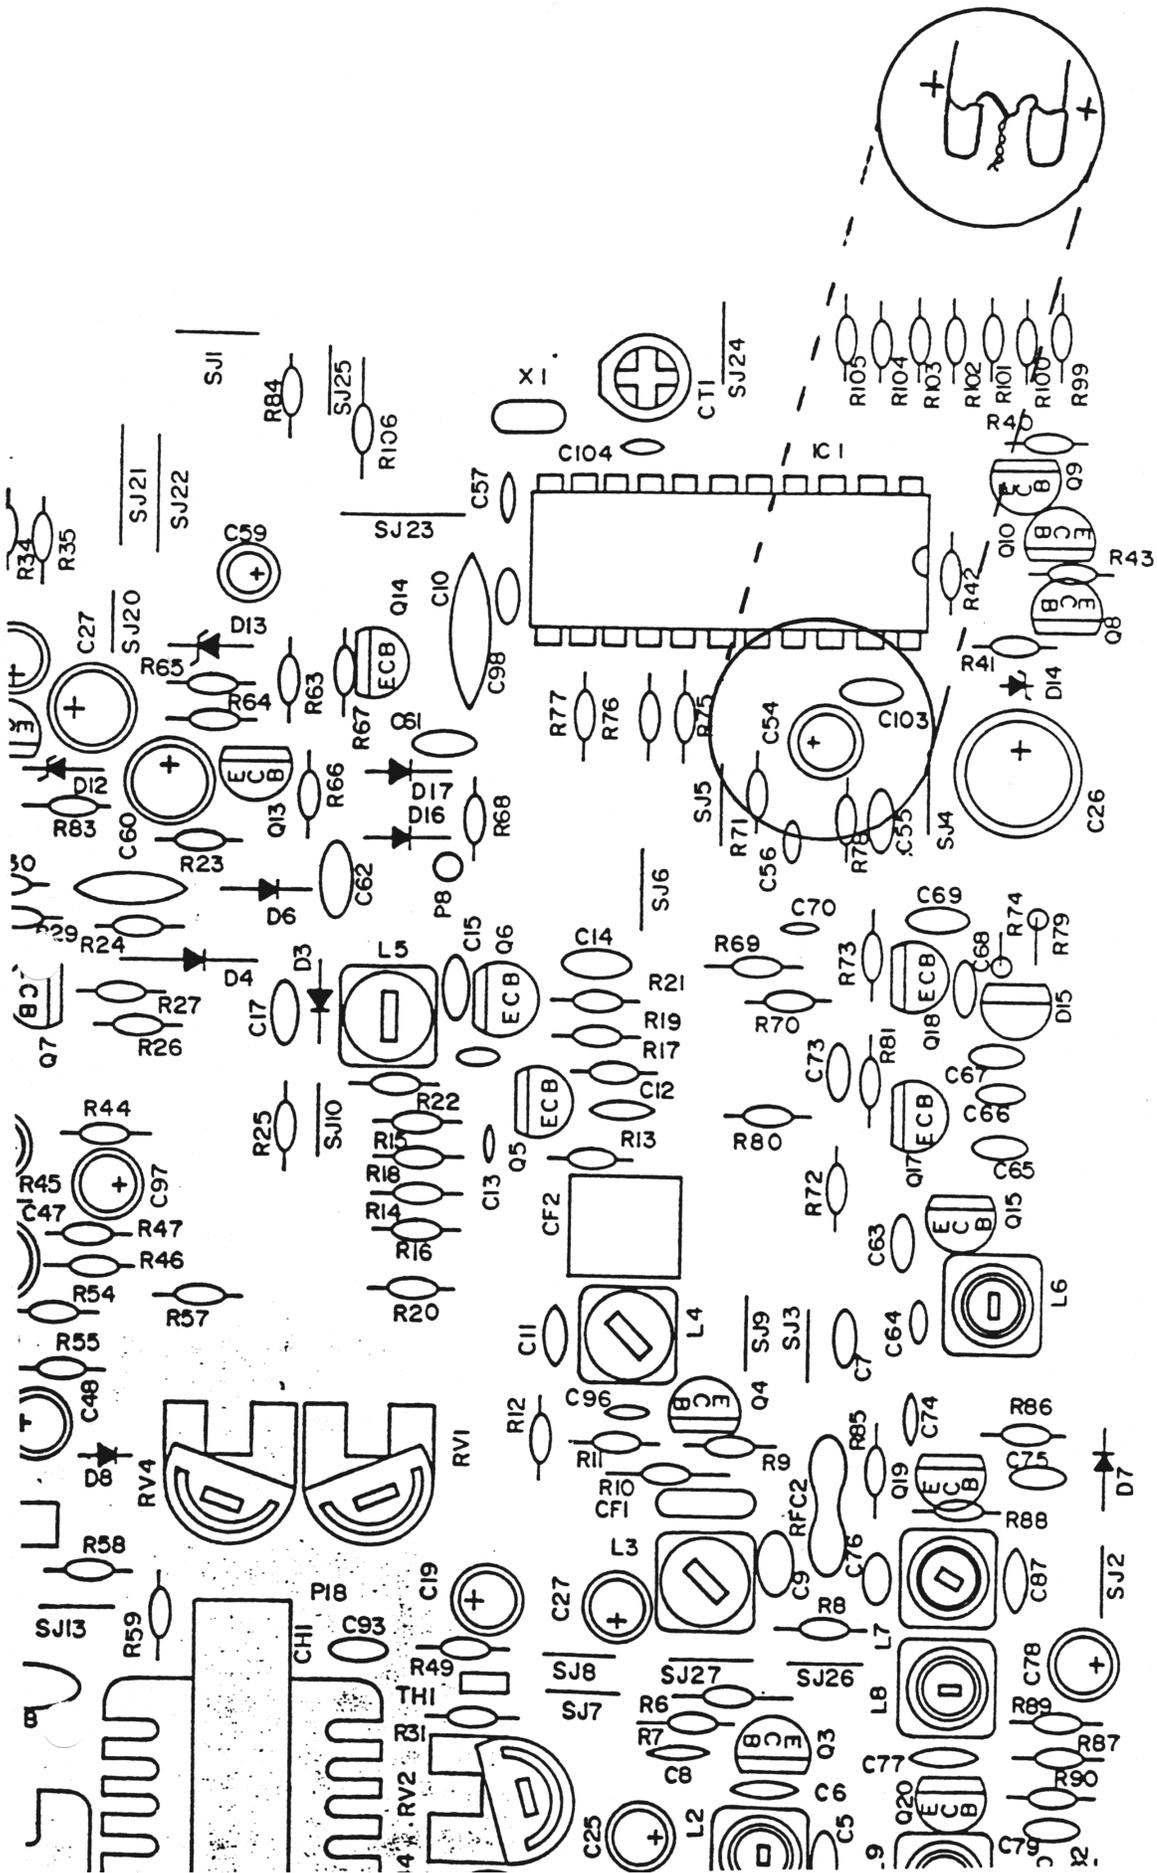
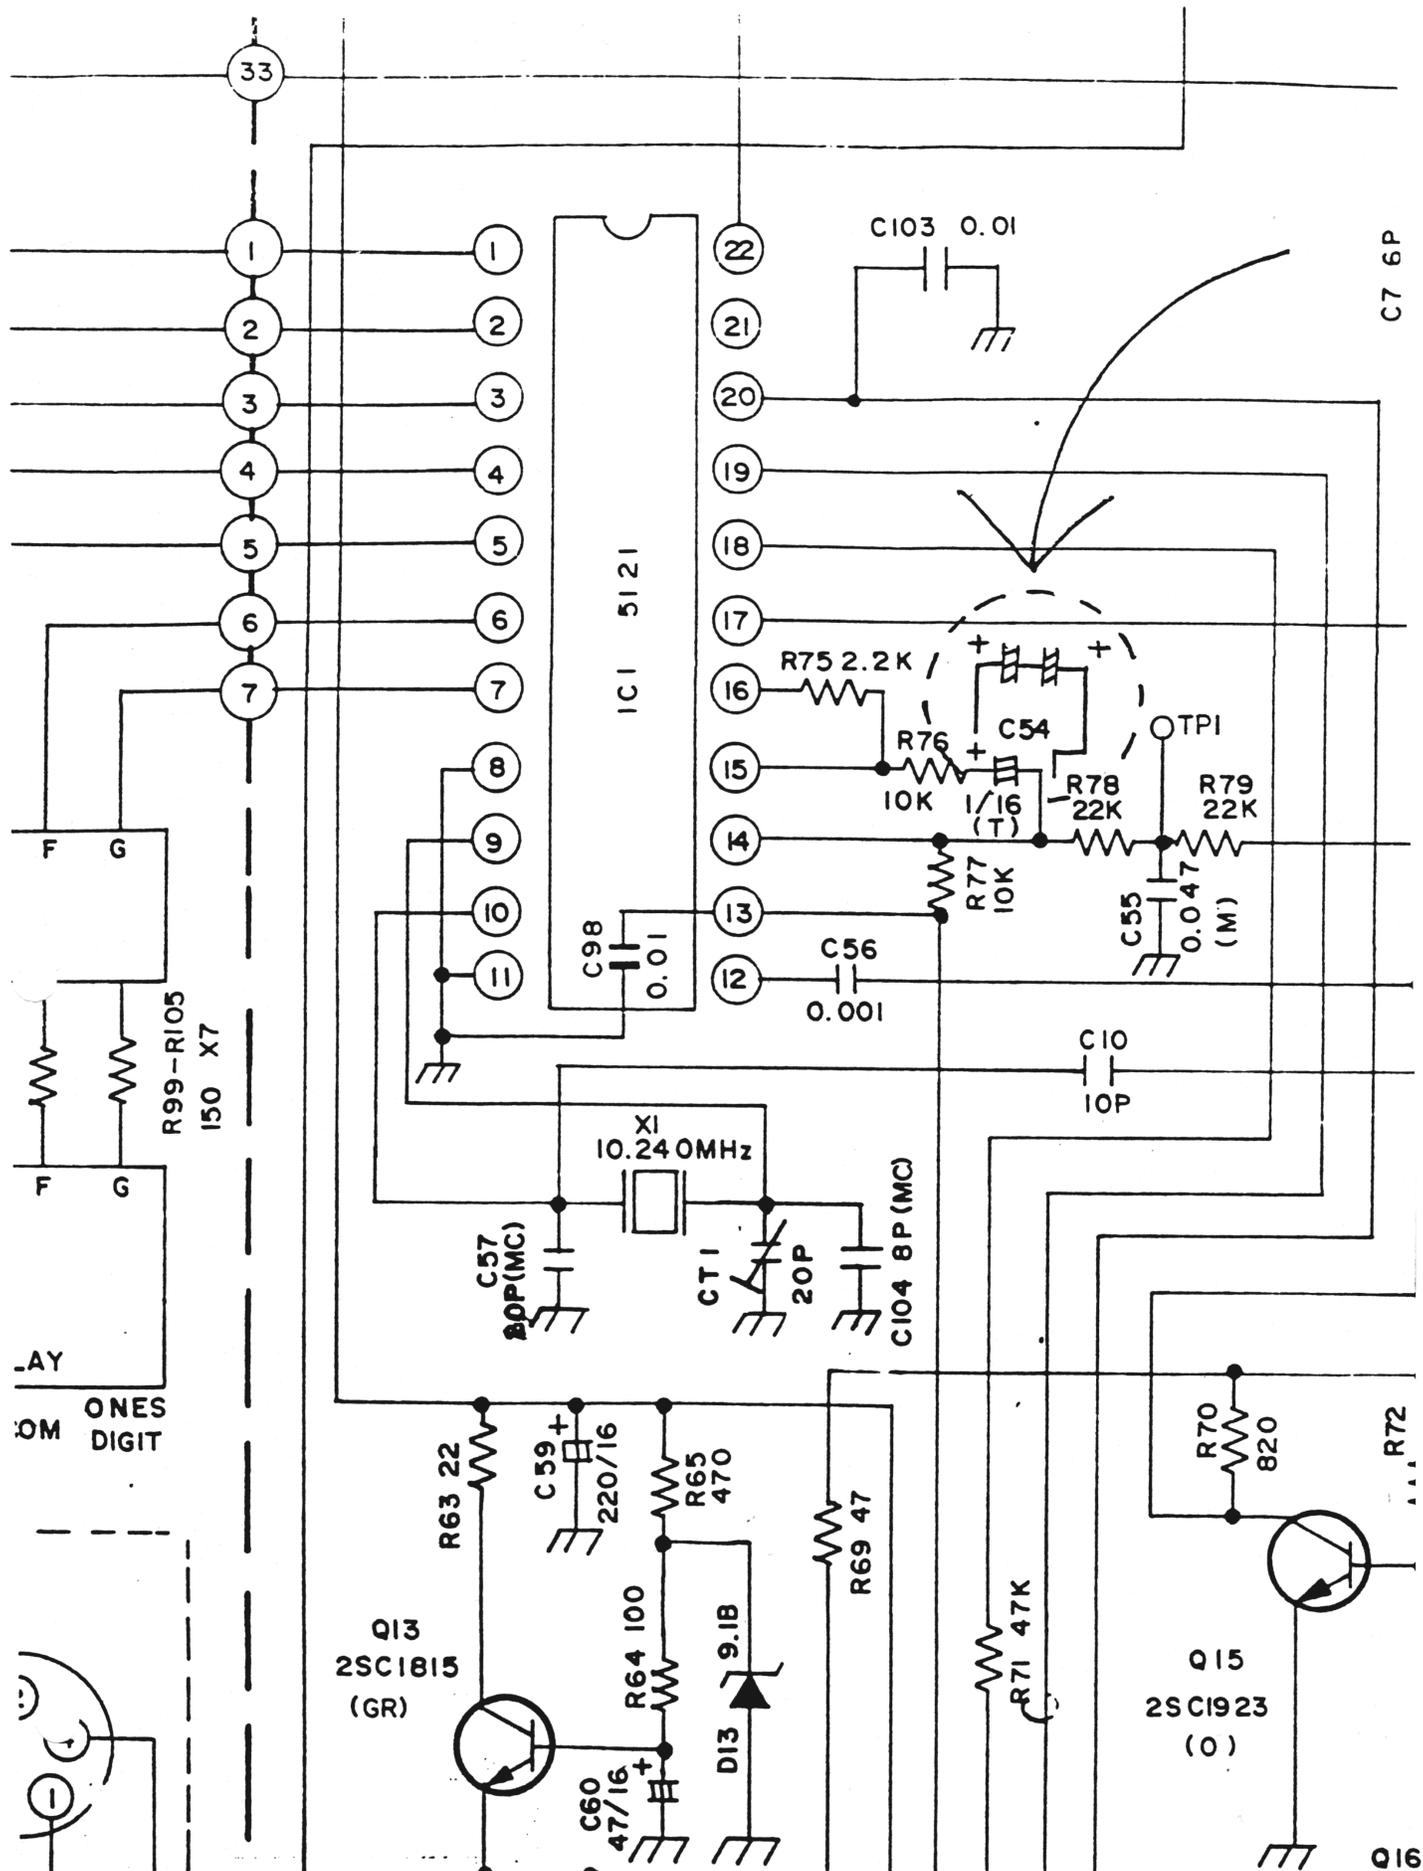
ACTION : Replace C54 with (2) 1uF, 16V tantalum capacitors in series (Non-Polar).

DETAILS OF CHANGE : 1. Locate and remove C54 (see attached illustrations). Discard this capacitor.

2. Prepare the two new capacitors by twisting together their negative leads and soldering.

3. Insert the finished capacitor pair in place of C54 such that one positive lead of each capacitor replaces the original C54 (net result is a non polar capacitor. Positive leads to circuit). Solder in place.

1. Connect Voltmeter to TP 1 (junction of R78, R79 and C55)
2. With unit in receive mode on channel 1, adjust dc voltage at TP 1 to 1.5 volts using L6.
3. Check for proper operation on channels 1 and 40, RX and TX.
4. Disconnect voltmeter.
