**Cobra 39 Plus Technical Bulletin 1290**

# TECHNICAL BULLETIN

**Number** 1290

MODELS AFFECTED : 39 Plus

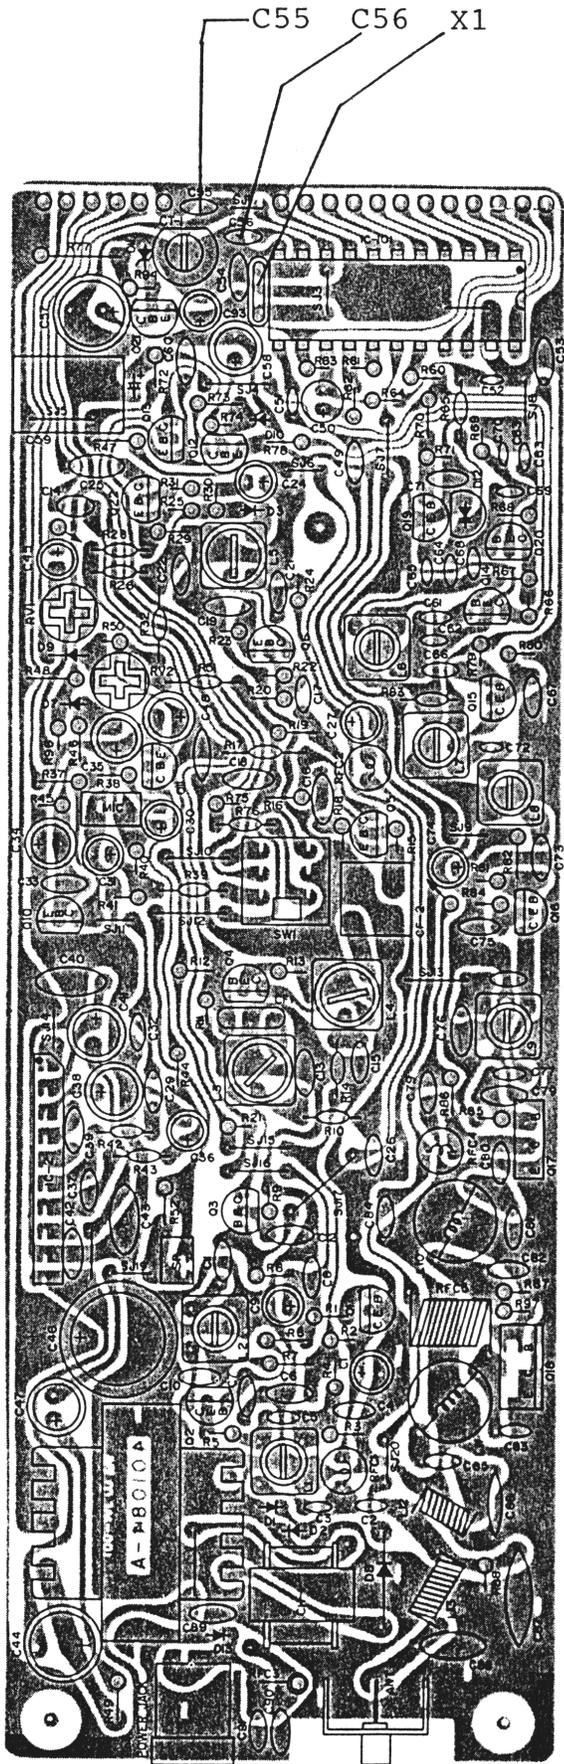
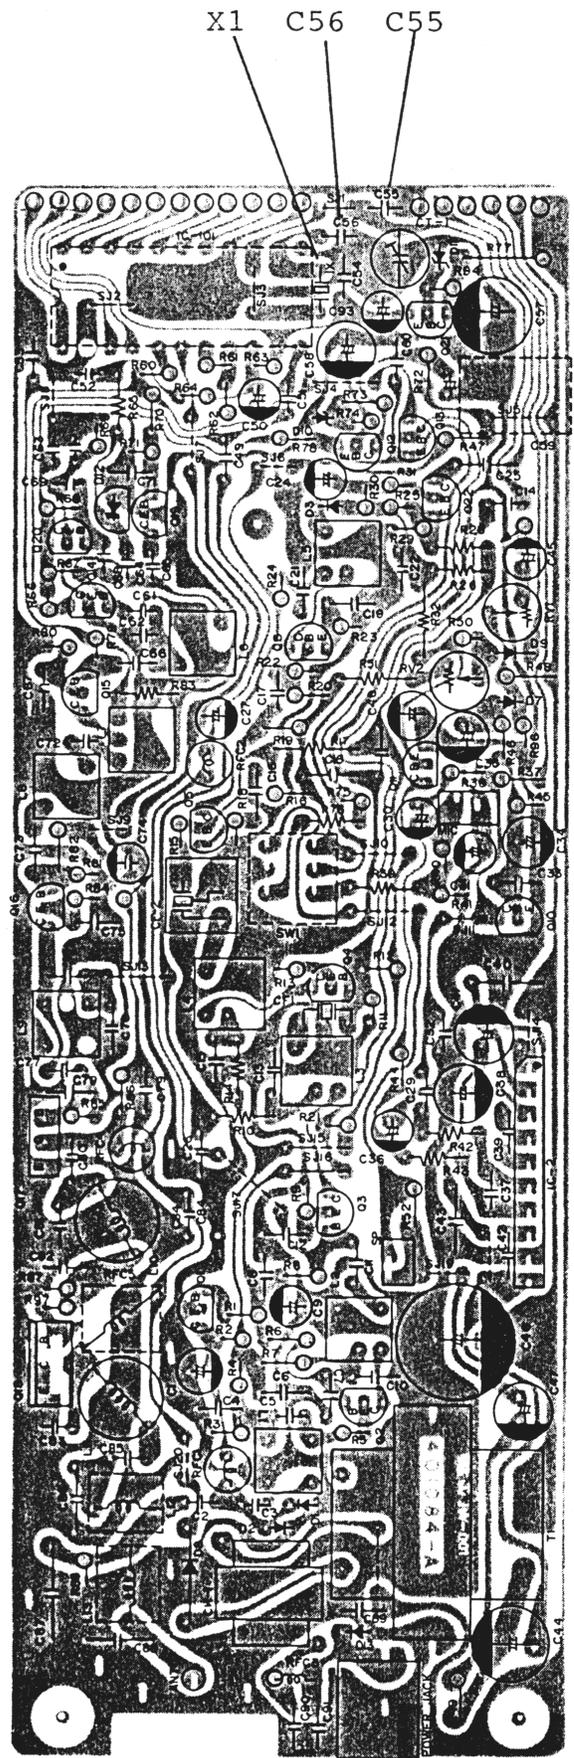
FIG. 1

SYMPTOMS : Progressively poor sensitivity or set inoperative (dead) with CH 9 LED lit and no up/down channeling capability.

CAUSE : 10.24MHz (X-1) crystal dead or activity below specification.

ACTION : Replace X-1 (see fig. 1), 10.24MHz crystal with Dynascan P/N 132-036-9-001.

OR Replace X-1, 10.24MHz crystal with Dynascan P/N 135-077-9-001 (Yel Vinyl) and change C55 & C56.  
C55 Cap. Mica 15pF/50V P/N 023-097-9-001  
C56 Cap. Mica 20pF/50V P/N 023-097-9-002

A. Locate C55 and C56 on P.C.B. and remove (see fig. 1).
