Cobra 67LTD Technical Bulletin 1284

TECHNICAL BULLETIN

Number 1284

MODELS AFFECTED: 67LTD

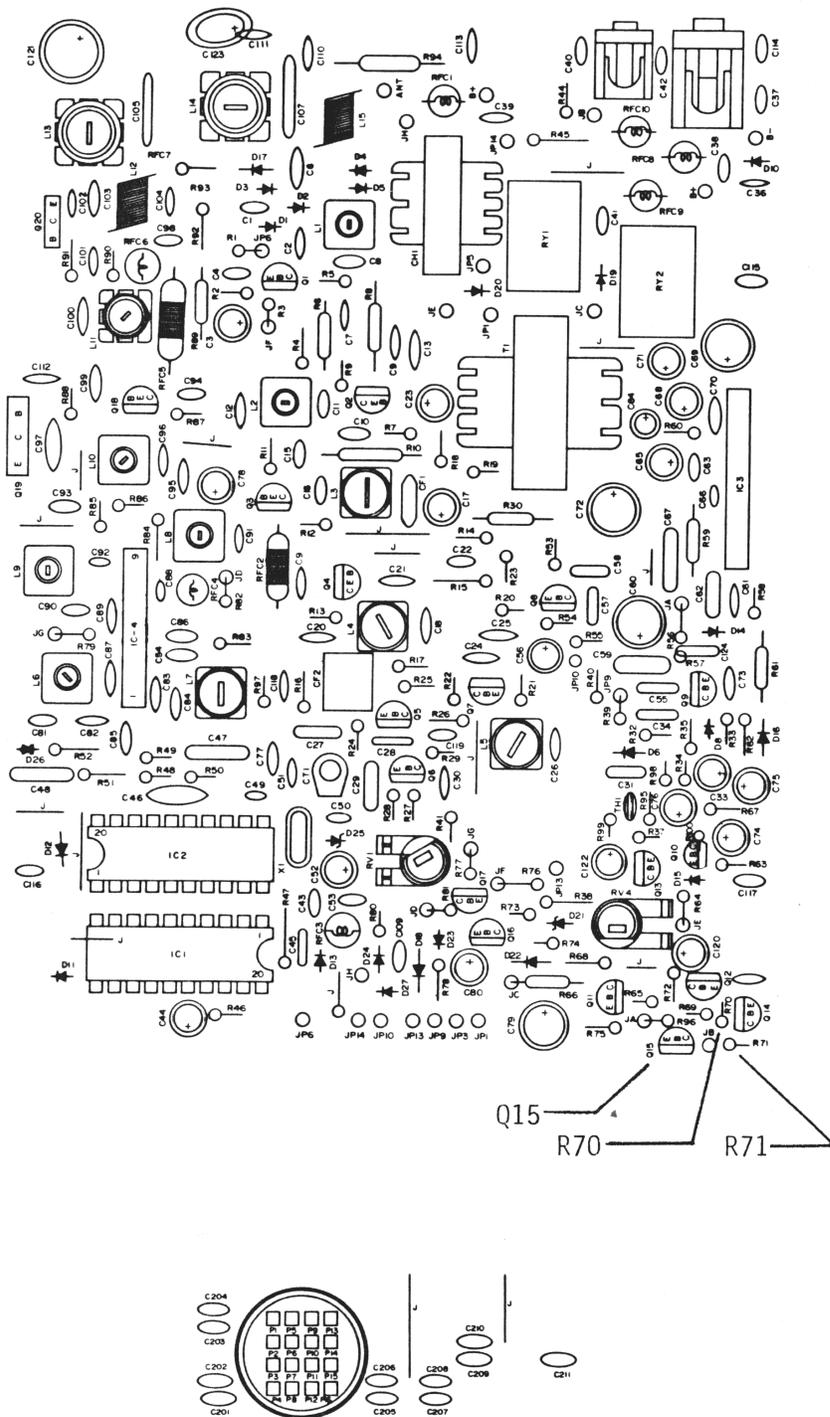
FIG. 1

SYMPTOMS: Car radio audio is heard from Automobile speakers instead of CB Audio when using a CA-63 Monitor Accessory with a 67LTD (Turned on and with NO Squelch).

CAUSE: The relay control circuit in the 67LTD causes the CA-63 relay to be de-energized when it should be energized. This condition causes the car radio Audio to be connected to the car speakers instead of the Audio from the 67LTD.

ACTION: Reverse the switching logic of the 67LTD relay control circuit by replacing the PNP device at Q15 with an NPN device. Increase the resistance at R70 and remove the resistor at R71 to improve low temperature operation.

1. Remove both covers of the base unit by removing 8 screws.
2. Unsolder, remove and discard 4.7k ohm resistor at R71. (See attached diagram.)
3. Install and solder a short jumper wire at R71.
4. Unsolder, remove and discard 10k ohm resistor at R70. (See attached diagram.)
5. Install and solder a 20K ohm 1/4 watt resistor (Dynascan P/N 002-104-5-203) at R70.

6. Unsolder, remove and discard MPS9681 at Q-15 (see attached diagram).
7. Install and solder an MPS9418T transistor (Dynascan P/N 176-115-9-004) at Q-15, observing REVERSE POLARITY (ie, E of new transistor in hole marked C, and C of new transistor in hole marked E. The B lead of the new transistor will still be in the hole marked B).
8. Replace both covers with 8 screws.
9. Check for proper CA-63 operation.
