Galaxy DX-33HP2 Echo-TB 911 Wiring Correction

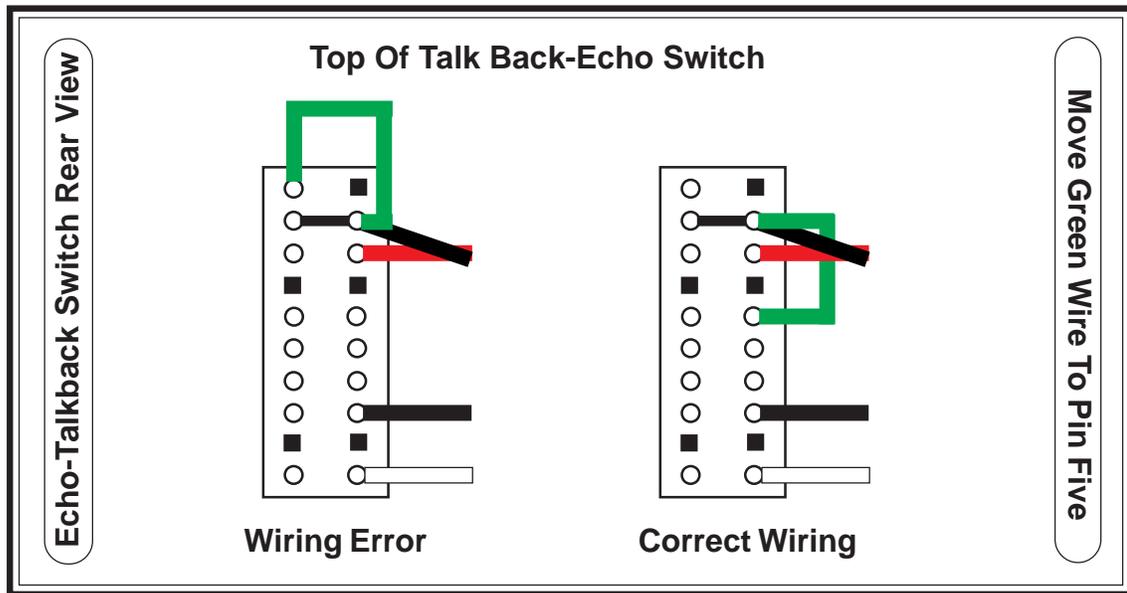
No Echo when Echo-Talkback Switch is in the Talkback position

The following Wiring Correction should be made on all Galaxy DX-33HP2 models with a serial number beginning in M911XXXX. This modification involves removing screws from the front bezel and accessing the back side of the Talk Back-Echo Switch. The Green Wire should be removed from it's current position and moved to Pin 5 of the Right Side Contacts. The diagram above shows the corrected wiring on this model.
