## SR-490HP Back Light Modification

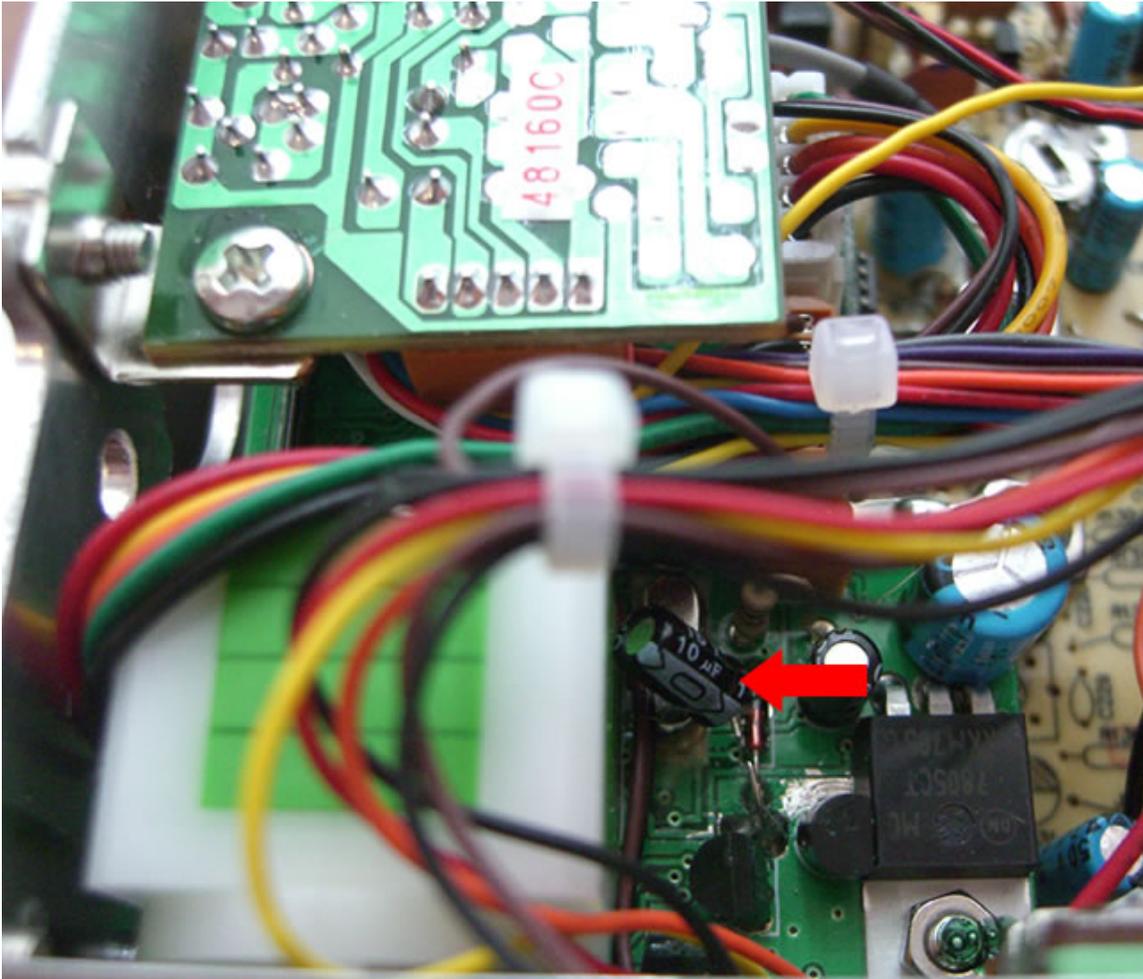
Some SR-490HP radios sold in late spring 2008 had a capacitor installed behind the channel selector. With the capacitor installed the dimmer will only dim a total of two stages instead of three. Clipping one leg of this capacitor will restore the radio to normal three stage dimmer operation. You can see in the above picture that one leg of the capacitor has already been clipped. The red arrow in the above picture points to the blue 10 uF capacitor in question.
