Magnum 1 Talk Back Modification

Only Applies to Radios with Serial Numbers Starting in 201552

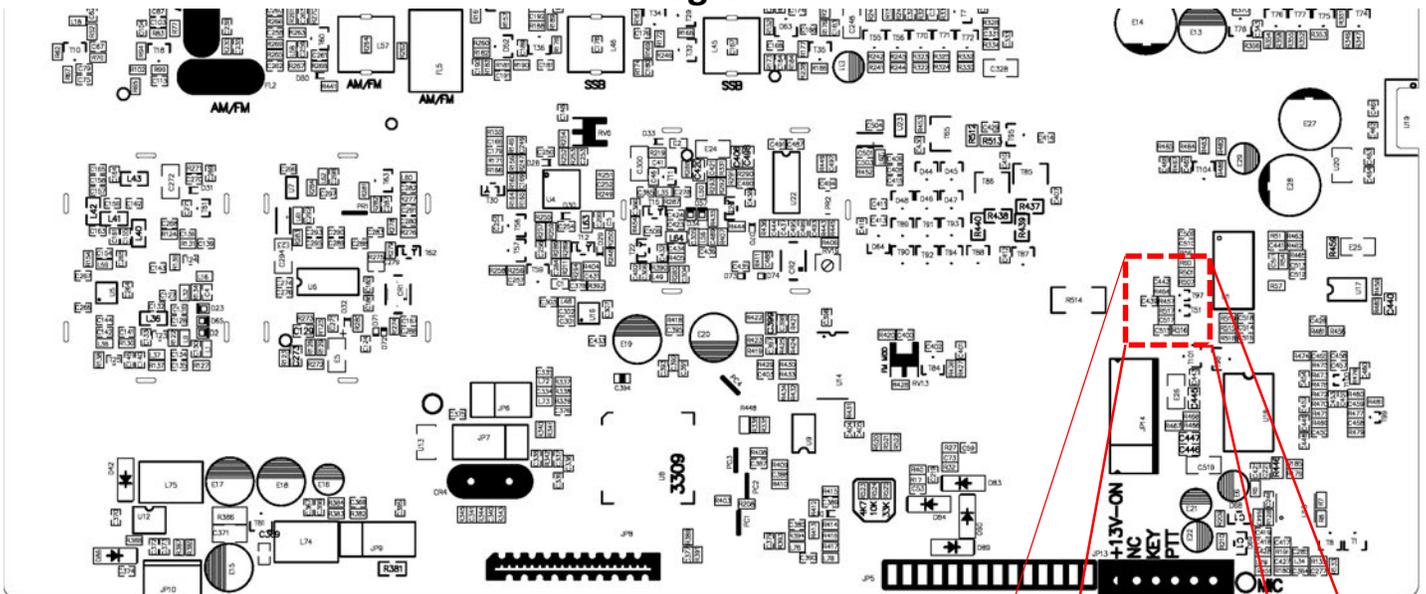
1. Disconnect radio from power and remove bottom (speaker) cabinet.
2. Near the front panel of the radio, locate and remove the capacitor at C515. See Diagram 1 below for general location of capacitor on main circuit board, and Photo 1 for detailed image of capacitor location.
3. Locate the solder pad from C515 that is connected to R516 (the 1K ohm (102) resistor adjacent to C515).
4. Next, locate the side of C439 that is furthest away from R457.
5. Across these 2 locations, solder a 0.1uF (104) ceramic disc capacitor. See Photo 1 and Photo 2 below for details. Note the orientation of the radio in photos.
