Craig L231 Service Bulletin# 012578

SB#012578  
January 25, 1978

SUBJECT: Modification of L231

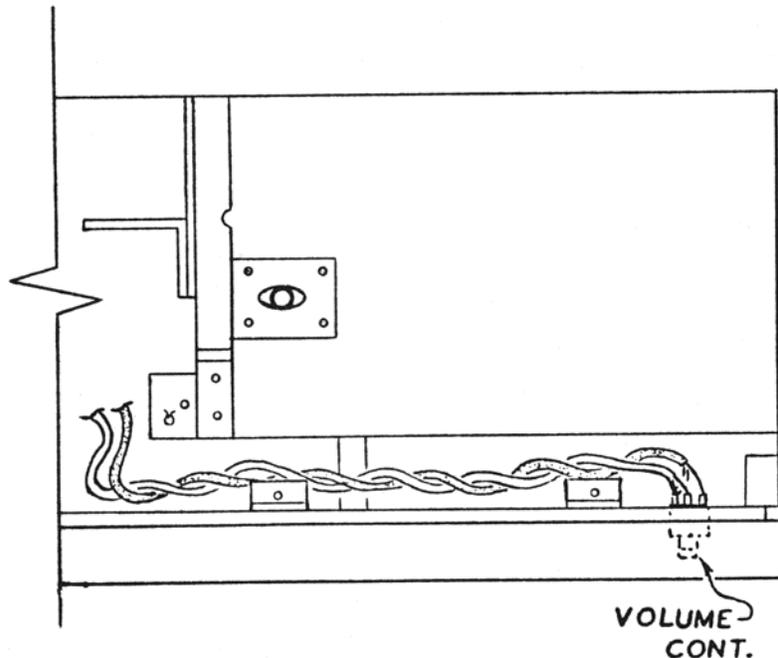
CHASSIS BOTTOM VIEW

PROBLEM: 60 cycle hum with Volume Control turned down

SOLUTION: Move the two shielded wires going to the Volume Control closer to the front of the CB, and twist them around each other as shown on Diagram. Position the wires for the lowest hum level.
